CONTRACTOR REPORT ARLCD-CR-80051

ULTRASONIC WELD SEALING  
OF M55 STAB DETONATORS

PHILIP C. KRAUSE  
SONOBOND CORPORATION  
200 E. ROSEDALE AVENUE  
WEST CHESTER, PENNSYLVANIA 19380

JANUARY 1981

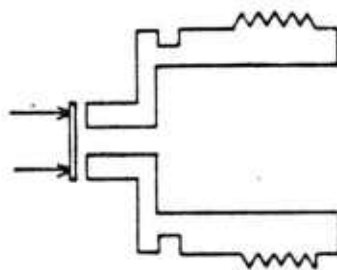
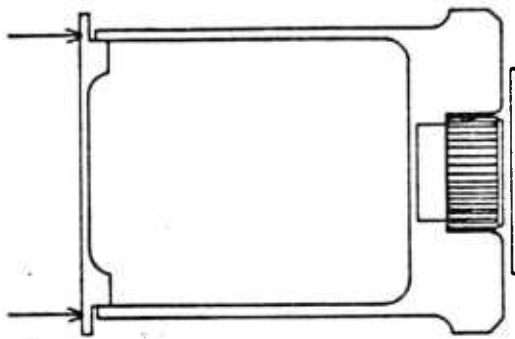
Figure 1. Representative container geometries for ultrasonic weld sealing.  
(Not to scale; arrows indicate location of weld periphery)

Figure 1 illustrates cross sections of representative containers that have been successfully weld-sealed by this method and Figure 2 provides photographs of some of the actual hardware. Certain of these containers have been welded in pilot runs of more than one thousand parts. In helium leak tests, they have reproducibly shown leak rates of substantially less than  $10^{-6}$  cc per minute at STP. One group of containers (Ref. 17) filled with M5 flake propellant was temperature cycled for periods up to 15 days and then exposed to solvent-saturated atmosphere (acetone and cyclohexane) for an additional 11 to 15 days. Subsequent closed bomb tests of the propellant indicated the ultrasonic seal to be 100 percent effective against solvent contamination.

From the outset, it was recognized that this was a difficult geometry to weld ultrasonically. As noted in Figure 1, all previous ring welding of small containers had involved an outward flange which could be rigidly supported in a welder anvil fixture or a rigid wall to which the cover could be welded. A moderate clamping force is required to effect good acoustic coupling between the welding tip and the parts to be welded and rigid support is essential to provide positive reaction to the clamping force application. With the M55 detonator as designed, the only support would be the explosive charges loaded in the cup and there was some skepticism as to whether these materials would provide the necessary rigidity.

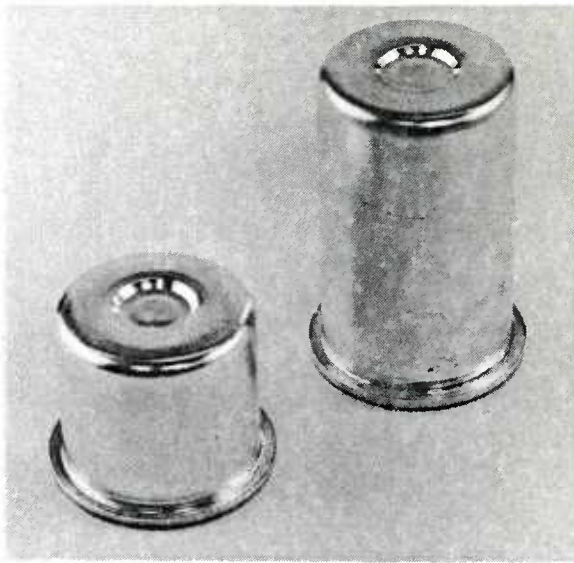
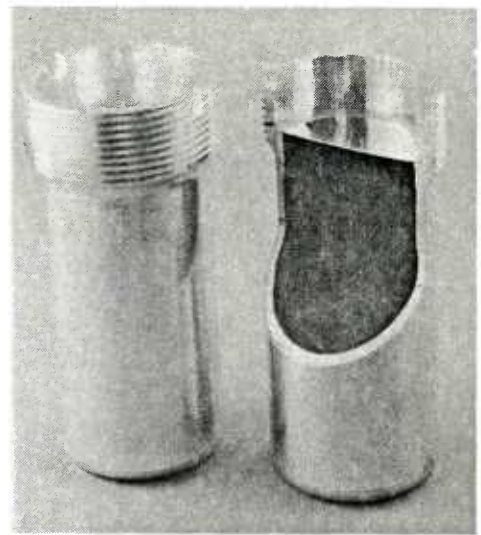
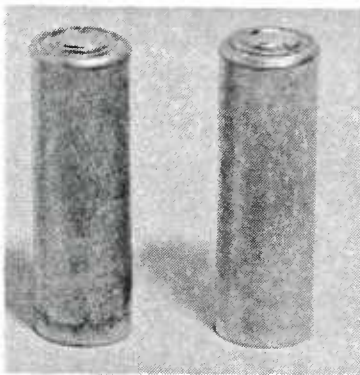
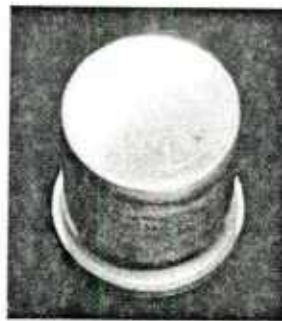
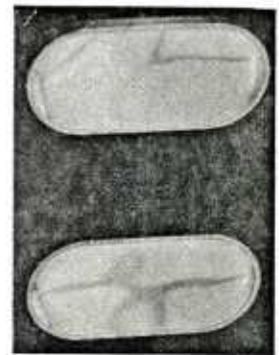
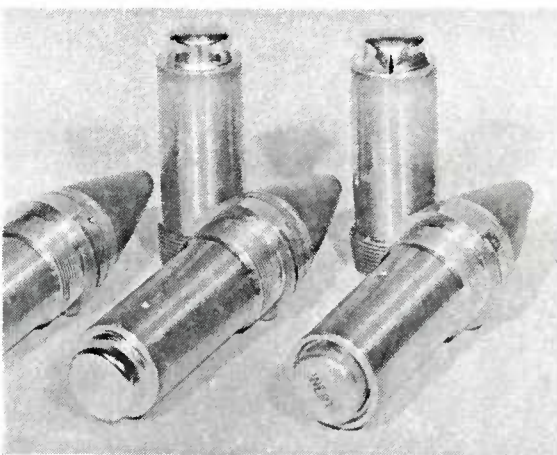
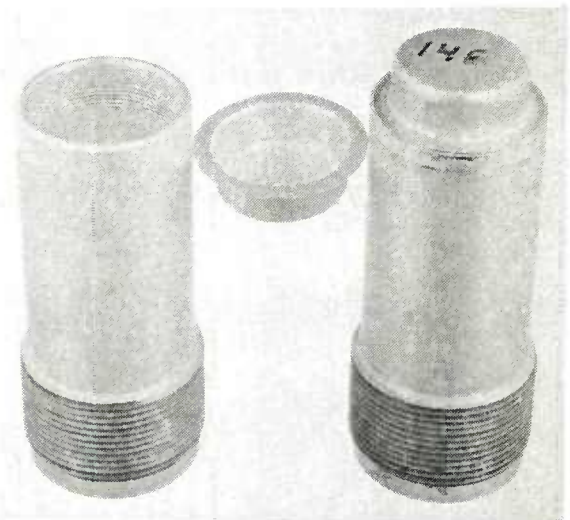
Figure 2. Typical ultrasonically weld-sealed containers.

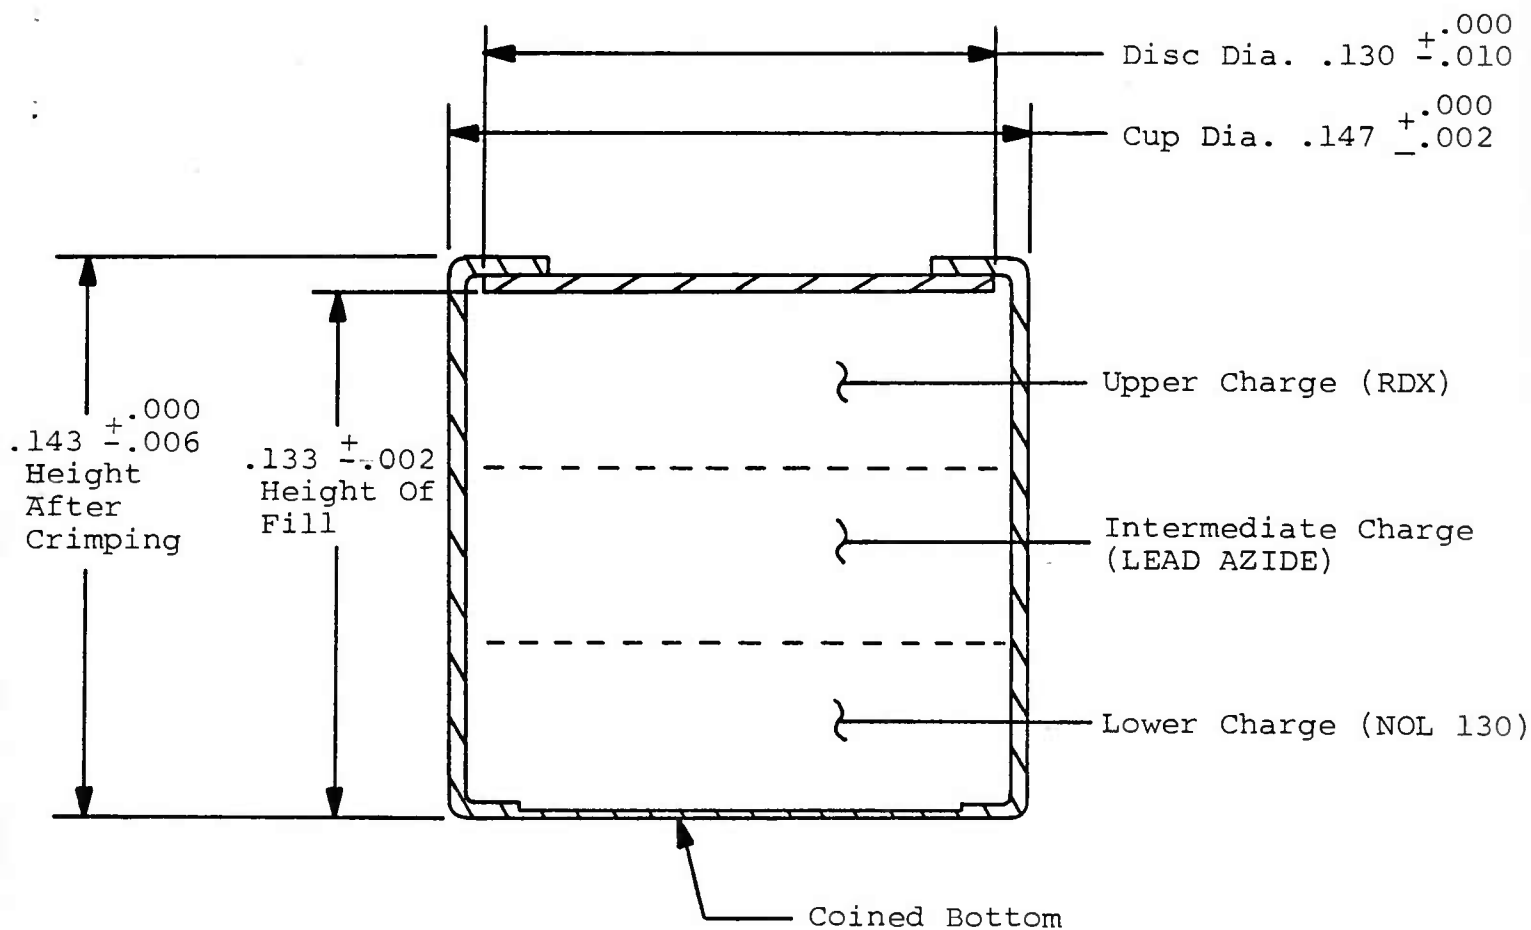
Figure 3. Geometry of M55 stab detonator

The M55 stab detonator consists of a cup loaded with three separate explosive charges and a cover disc over which the edges of the cup are crimped. The geometry is shown in Figure 3.

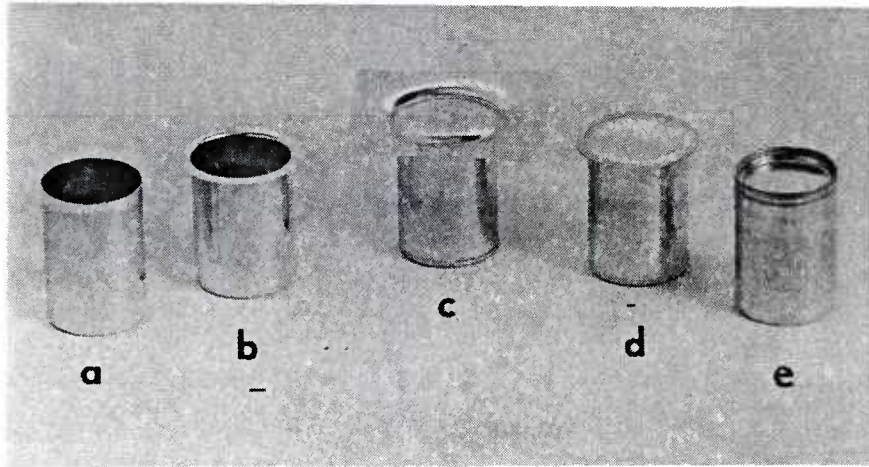
Figure 4. Welding and re-forming of cylindrical cup.

- a. Initial cylindrical cup
- b. Flange formed on cup
- c. Cover welded to flange
- d. Cover trimmed to flange periphery
- e. Flange re-formed to cylindrical shape

Some consideration was given to the redesign of the detonator to provide an outward flange on the cup which would ensure reproducible welding. If desirable, the flange could be re-formed to a cylindrical shape after welding. Figure 4, for example, shows a procedure that has been successfully used for this type of welding. The containers were reproducibly leak-tight even after re-forming.

It appeared that successful use of ultrasonic welding for sealing these detonators could be achieved only by altering the geometry of the cup to include an outward flange that could be rigidly supported on an appropriate welding anvil. As noted, such a configuration has repeatedly been successfully welded to achieve reproducibly leaktight seals, which remain leaktight even after redrawing the flange to a cylindrical geometry, as shown in Figure 4.

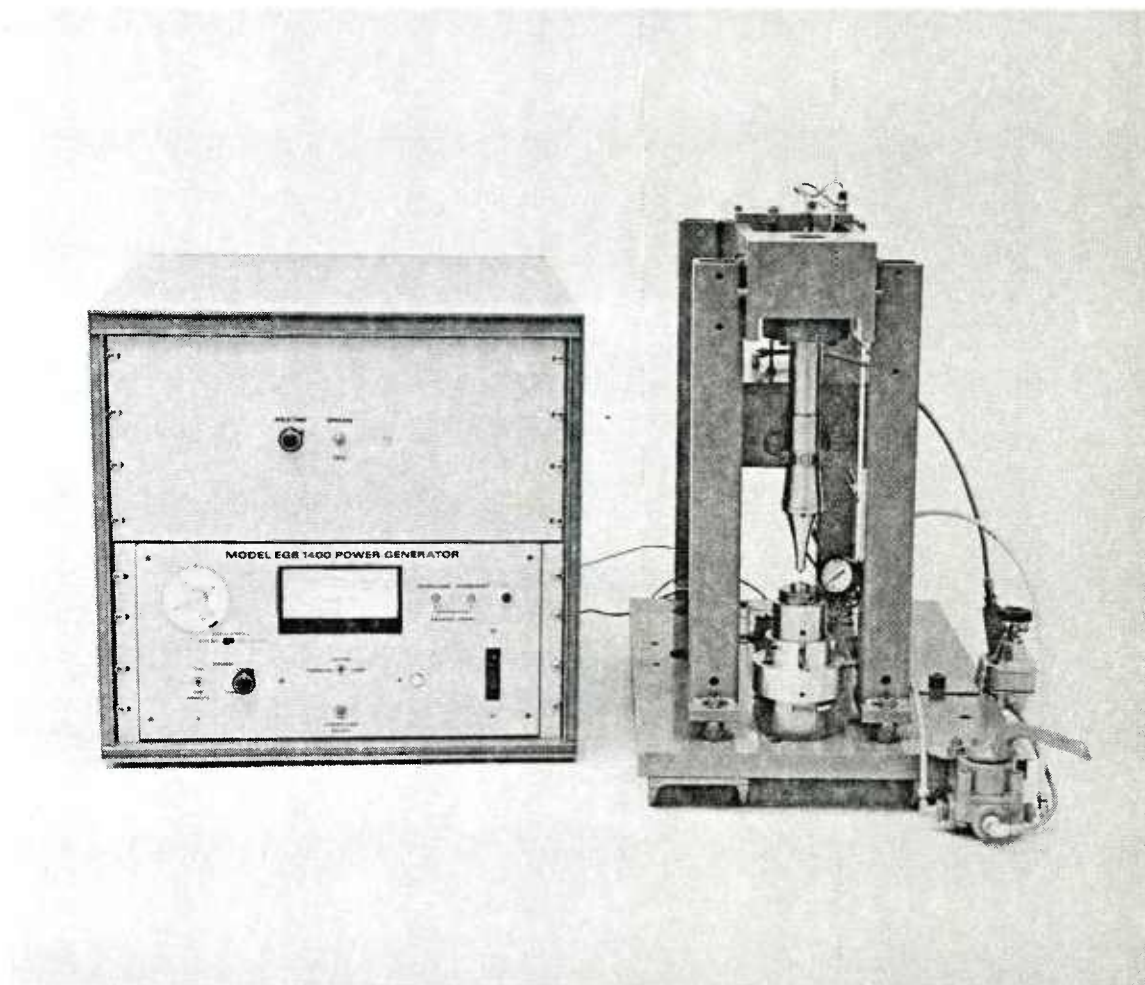
Figure 5. Ultrasonic ring welder Model 2812 with EGB 1400 frequency converter.

The welding equipment used to seal the detonators was an ultrasonic ring welder Model MR-2812 (Figure 5,) which operated at an ultrasonic frequency of 28 kilohertz and with a maximum power capacity of 1200 RF watts input to the transducers. This machine consisted

of two major assemblies: an ultrasonic welding head and a frequency converter to supply the necessary high-frequency electrical power to drive the head. The welding head was enclosed in a safety housing and the frequency converter, which contained the essential welding controls, could be remotely located, with only light-weight cable connections between the two units. Specifications for the equipment are provided in Table 2.

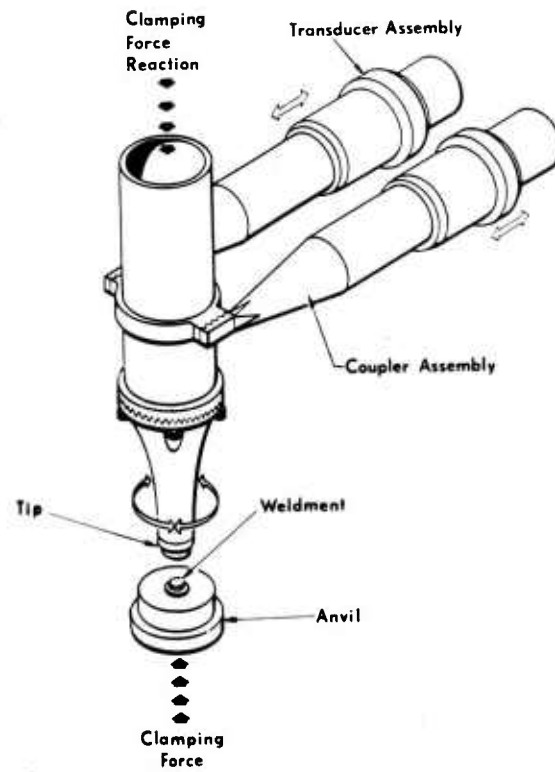
Figure 6. Schematic diagram of ultrasonic ring welding system.

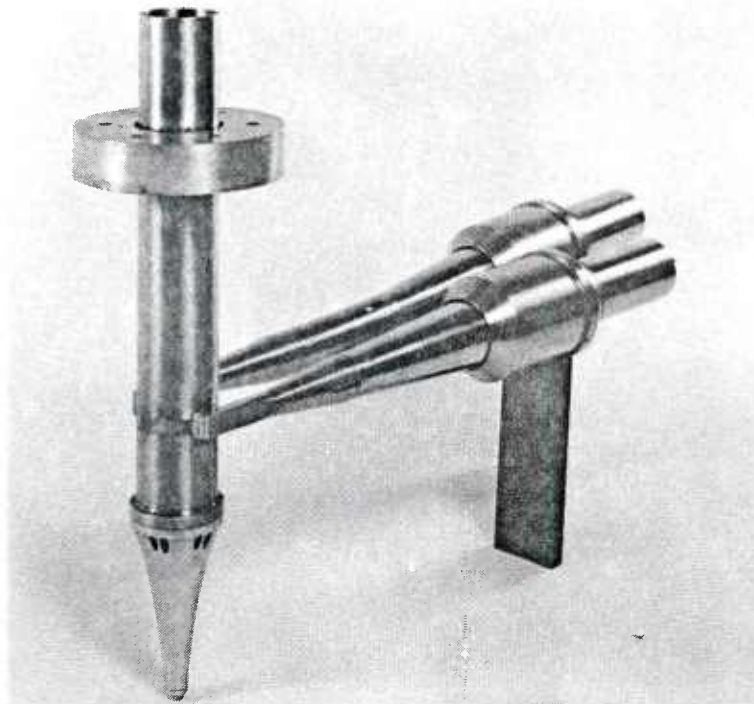
Figure 7. Acoustic system for an ultrasonic ring welder.

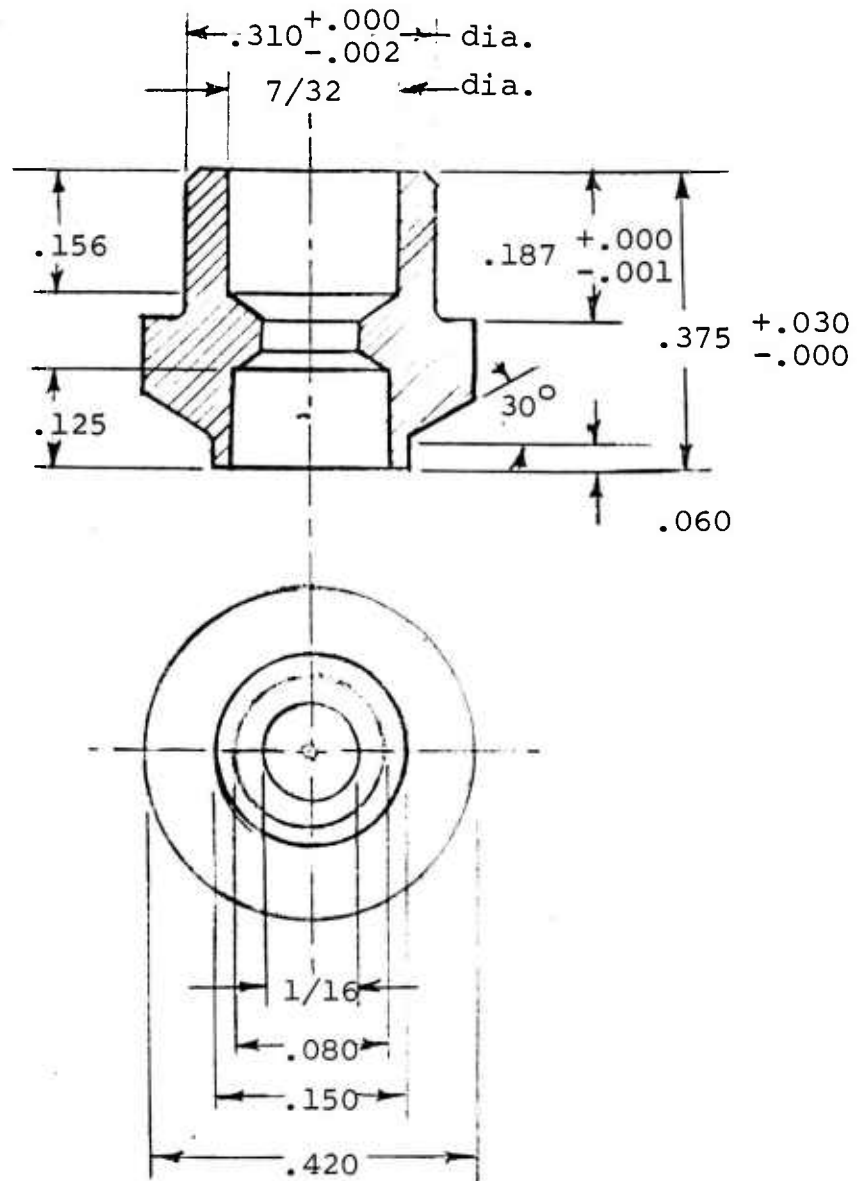
Figure 8. Ultrasonic ring welding tip for M55 detonator.

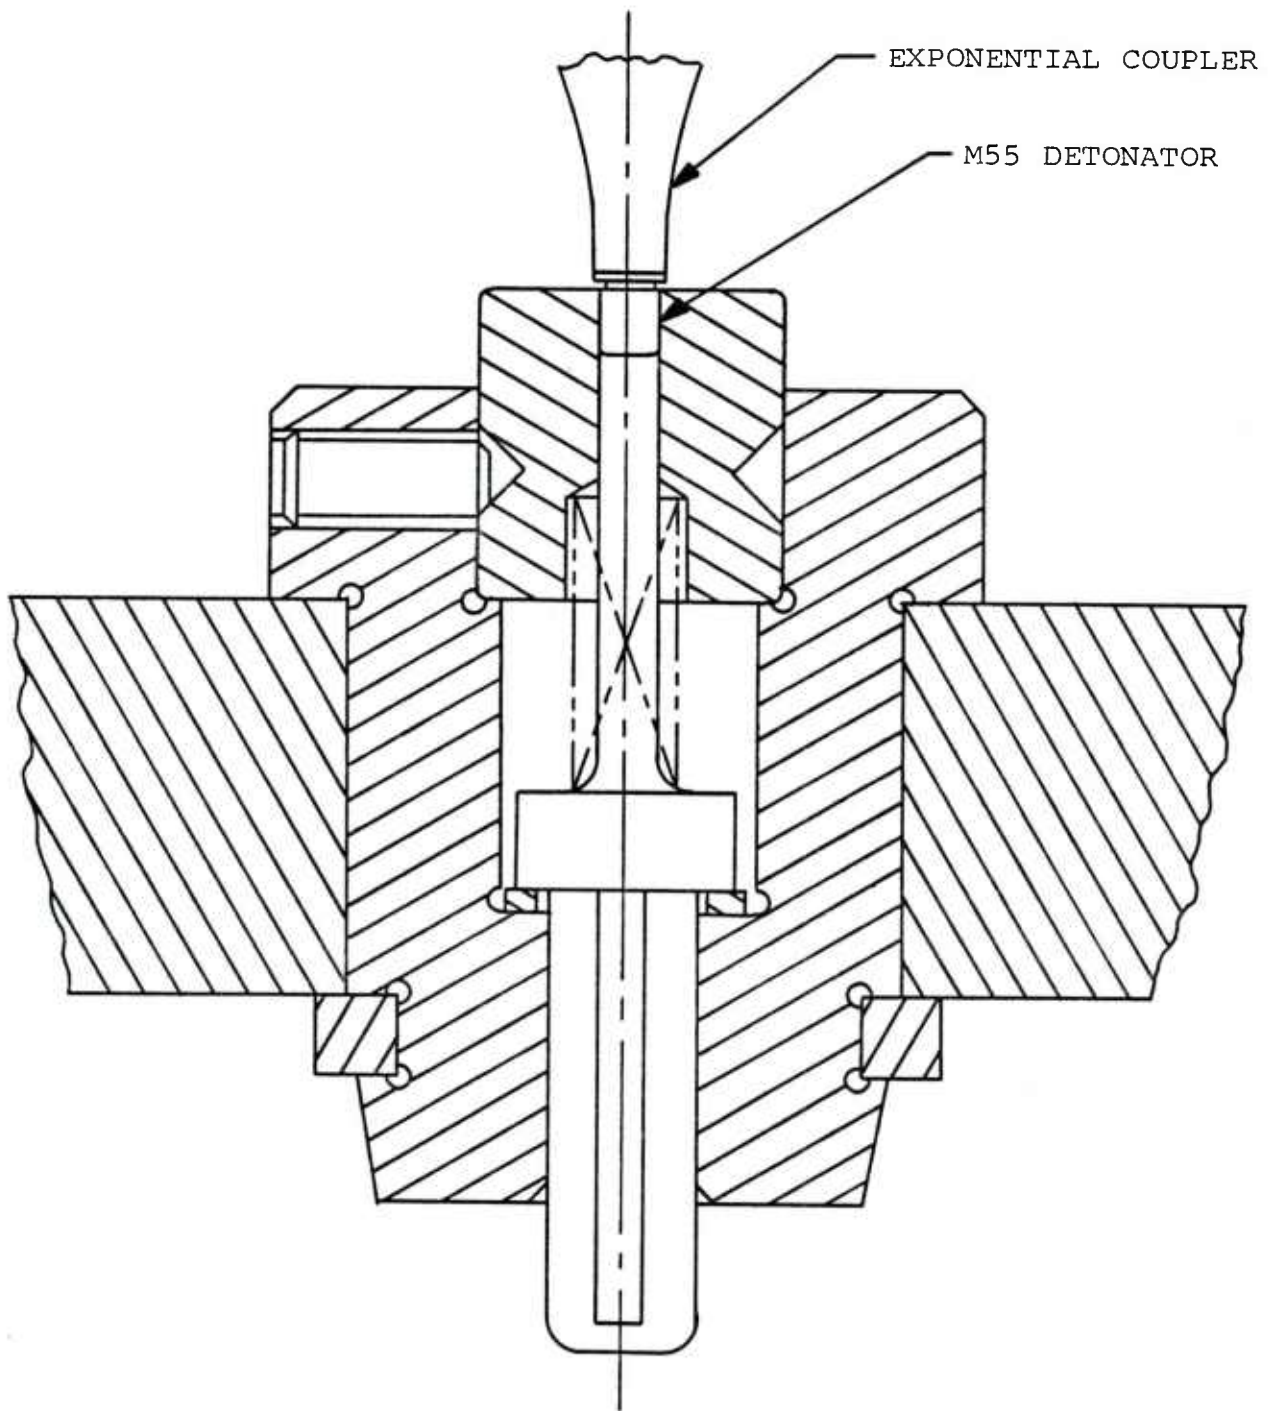
Figure 9. Geometry of Iowa loader nest assembly.

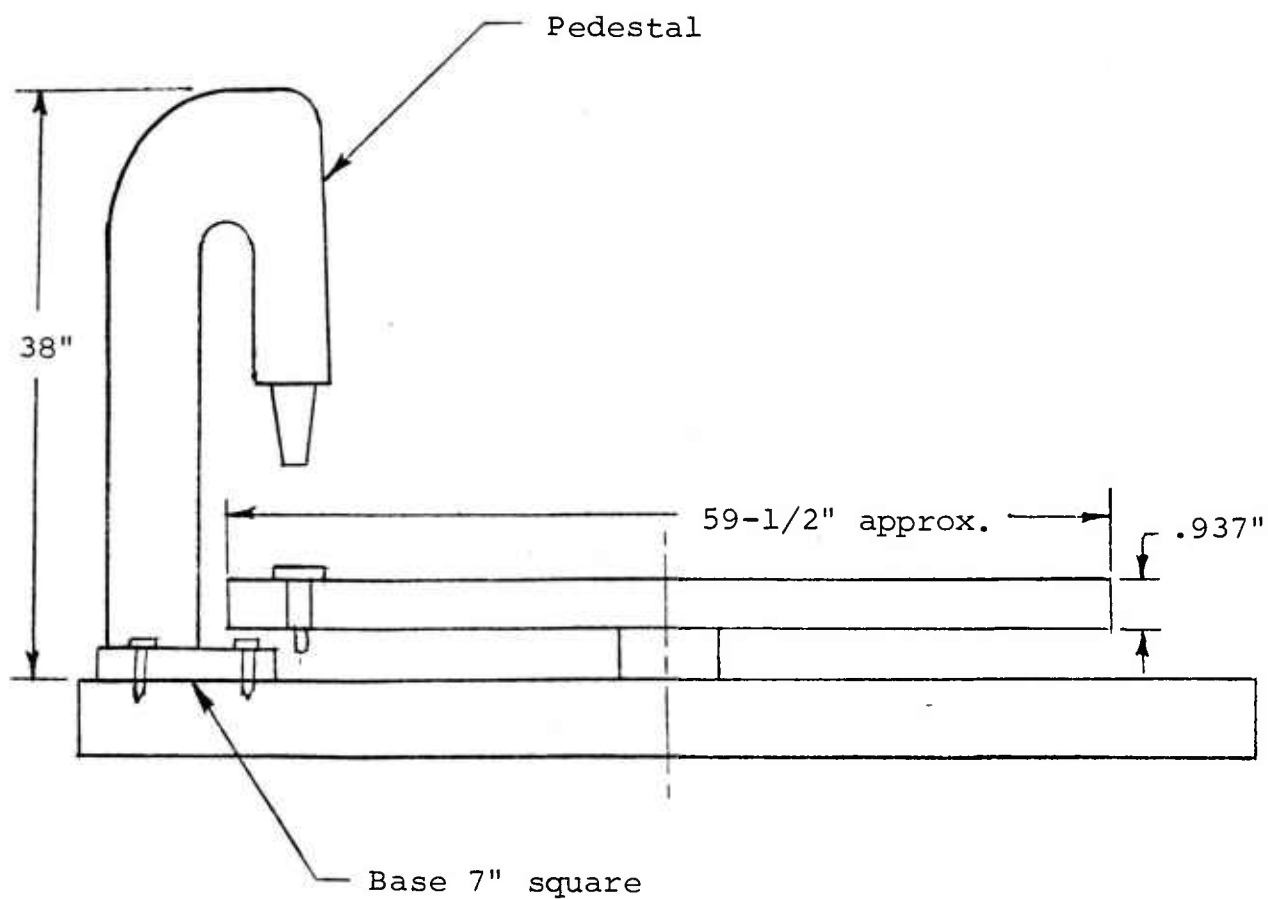
Figure 11. Side view of ultrasonic welder frame installed on Iowa Loader (not to scale).

was evaluated and found to work satisfactorily. There appeared to be no impediments to installing a modified welding head inside the Iowa loader. The frequency converter could be located outside the loader enclosure. Holes were available to accomodate the cables and air lines to the welder. A possible arrangement for the various stations is shown in Figure 10 and Figure 11 shows how an ultrasonic welding pedestal could be installed at the welding station.

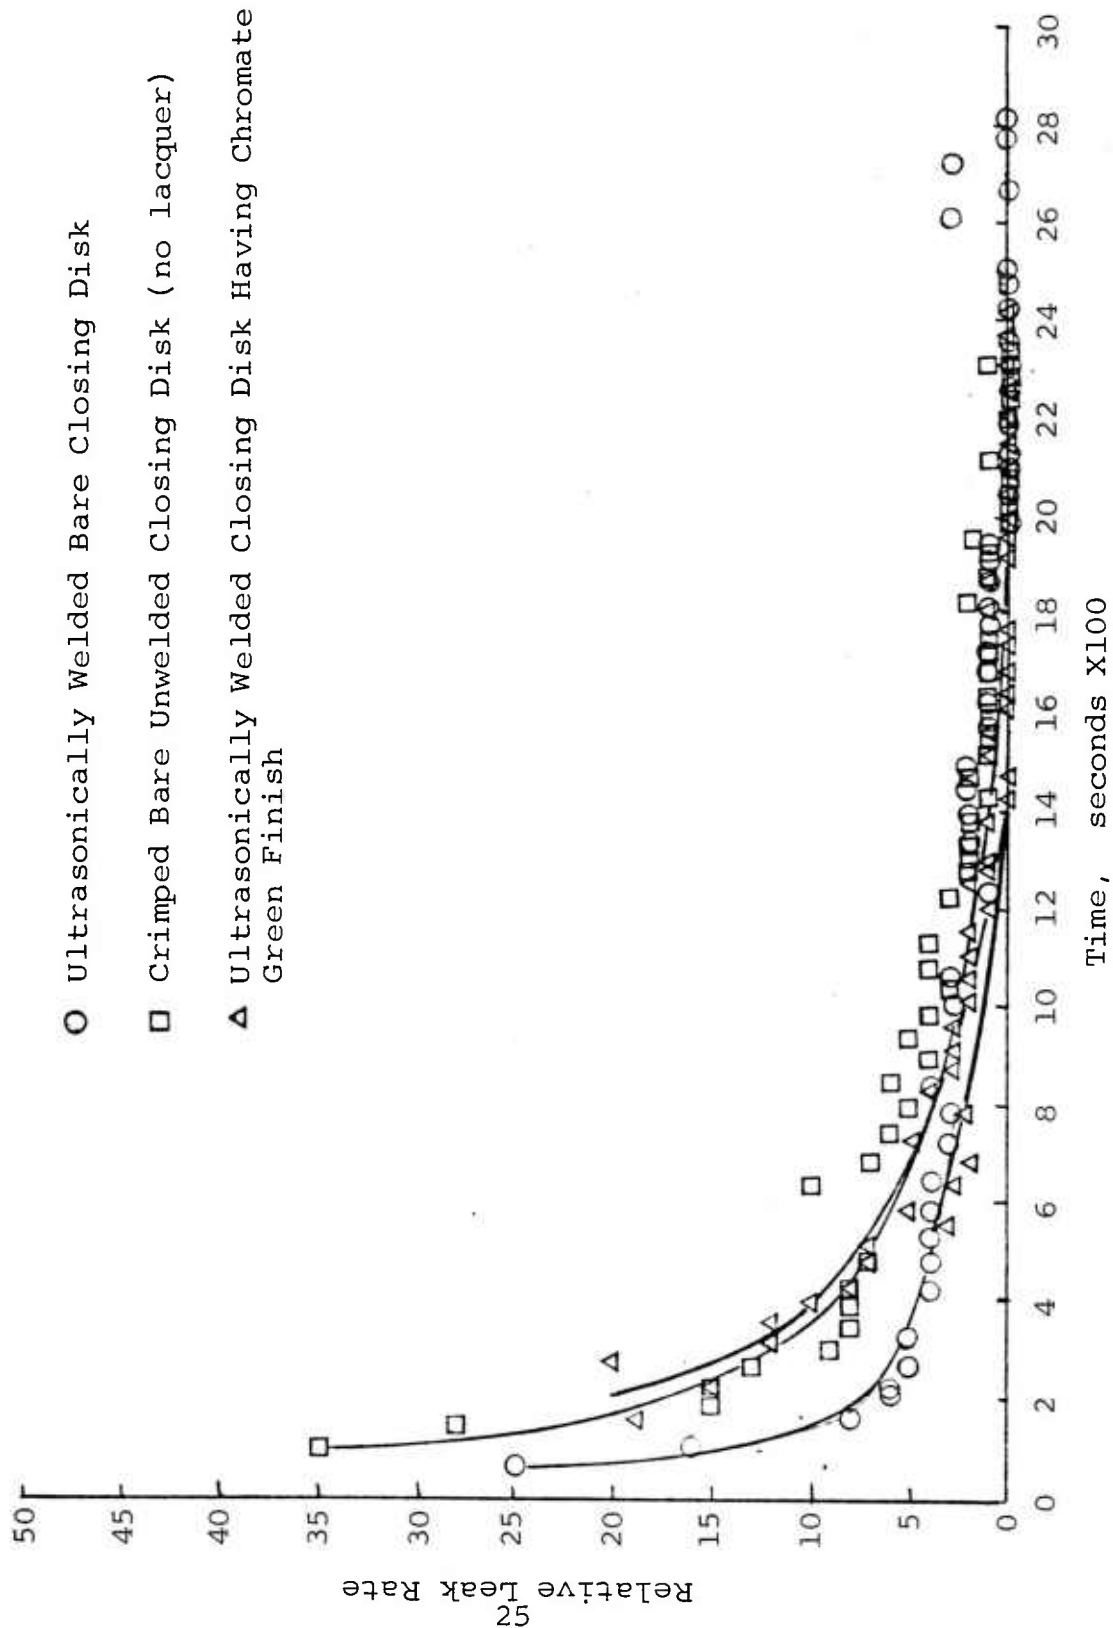
Figure 12. Relative leak rates for detonators as a function of time after removal from pressure vessel.

The results of the helium leak tests are provided in Appendix C and summarized in the curves of Figure 12. Both types of ultrasonically welded detonators and also the units that had been crimped over plain discs, but unwelded showed approximately equivalent leak rates. The curves of Figure 12 show an initial sharp decline in leak rate, followed by a leveling off. Zero leak rate was achieved in about 25 to 33 minutes after exposure to ambient atmosphere. There was some indication that the units ultrasonically welded with plain discs were superior to those ultrasonically welded with chromated discs, but the difference is probably not significant.

However, no leakage at all was detected with any of the standard production detonators (crimped and lacquered.) This could be attributed to either of two causes: Either these units were completely leaktight to the limits of detection of the mass spectrometer ( $10^{-11}$  standard cc/sec,) or the leaks were so gross that all helium was exhausted during purging of the pressure vessel. Further testing to compare these detonators with unlacquered plain, crimped units led to the conclusion that the standard items were leakproof. (See Appendix C.)

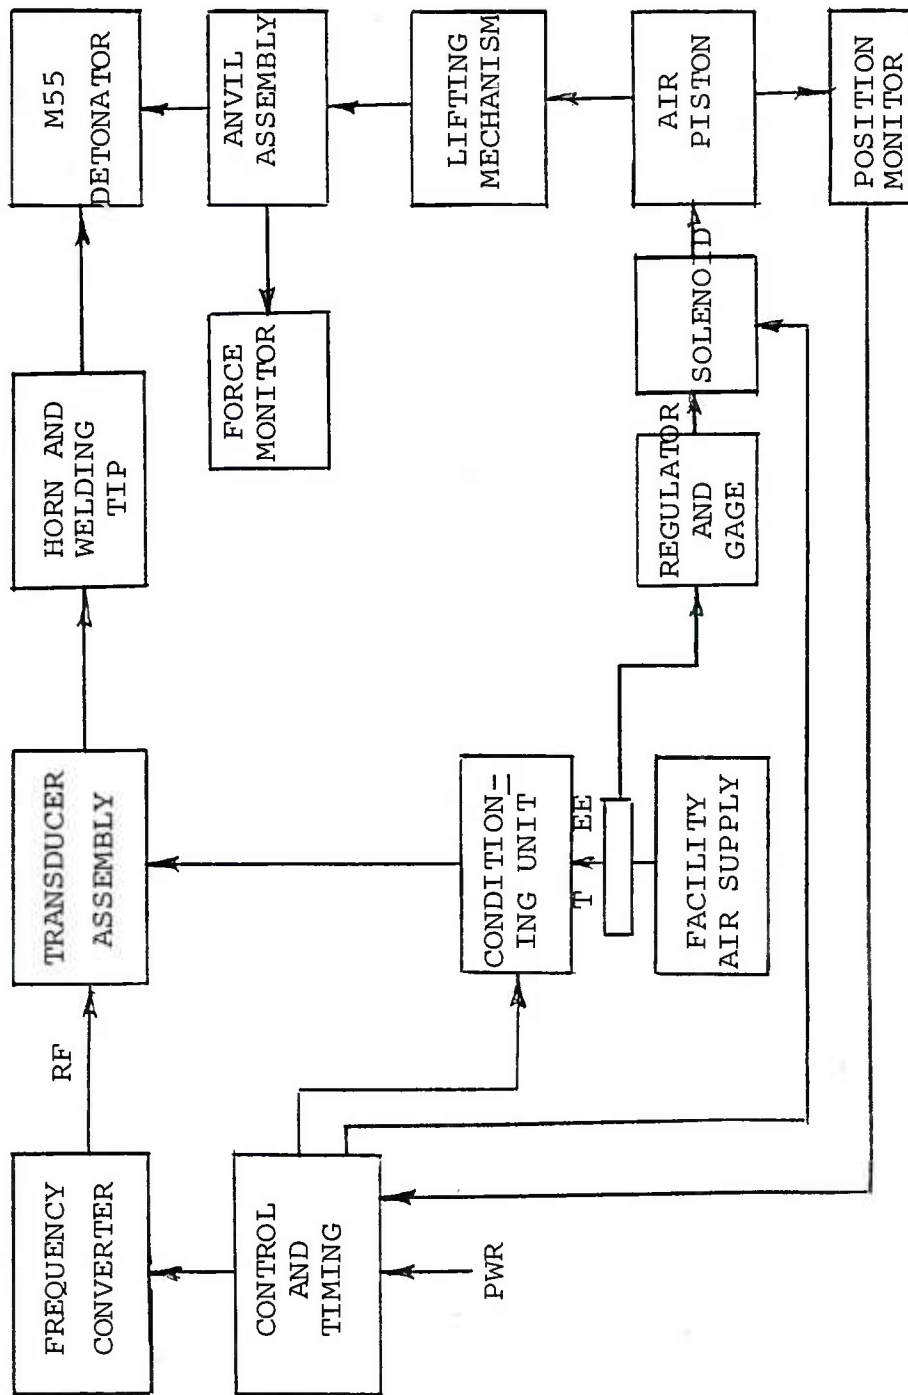
Figure A-1. Functional block diagram - ultrasonic welder.

The equipment consists of the welder and a remotely located control console. Since the console is in a protected area, personnel hazards, such as shock, are not a part of this preliminary assessment.

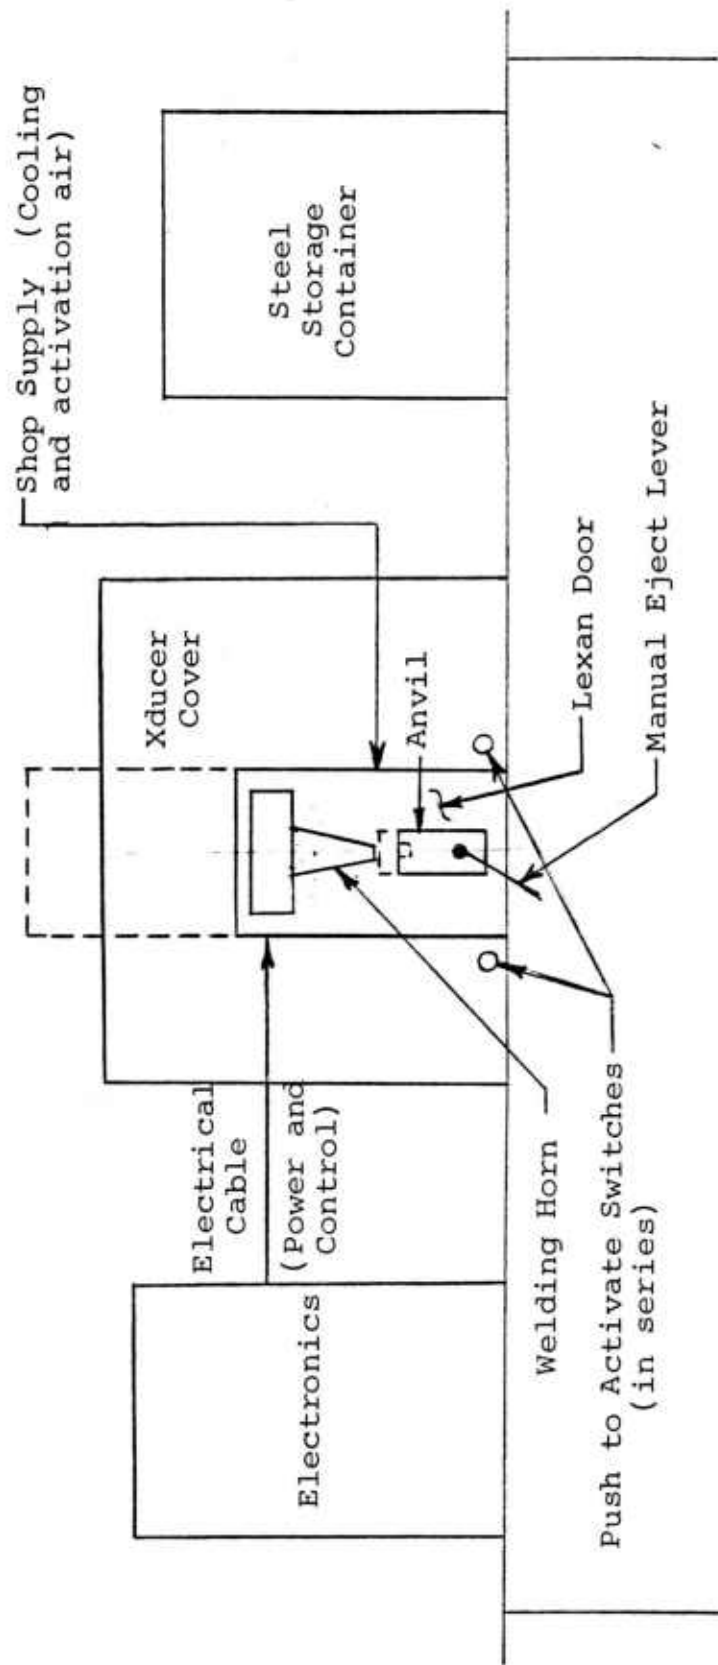
Figure B-1. Ultrasonic welding setup.

The welding of inert detonators was done using the same test setup. Welds obtained were all satisfactory, indicating proper operation and setting of the welding equipment.

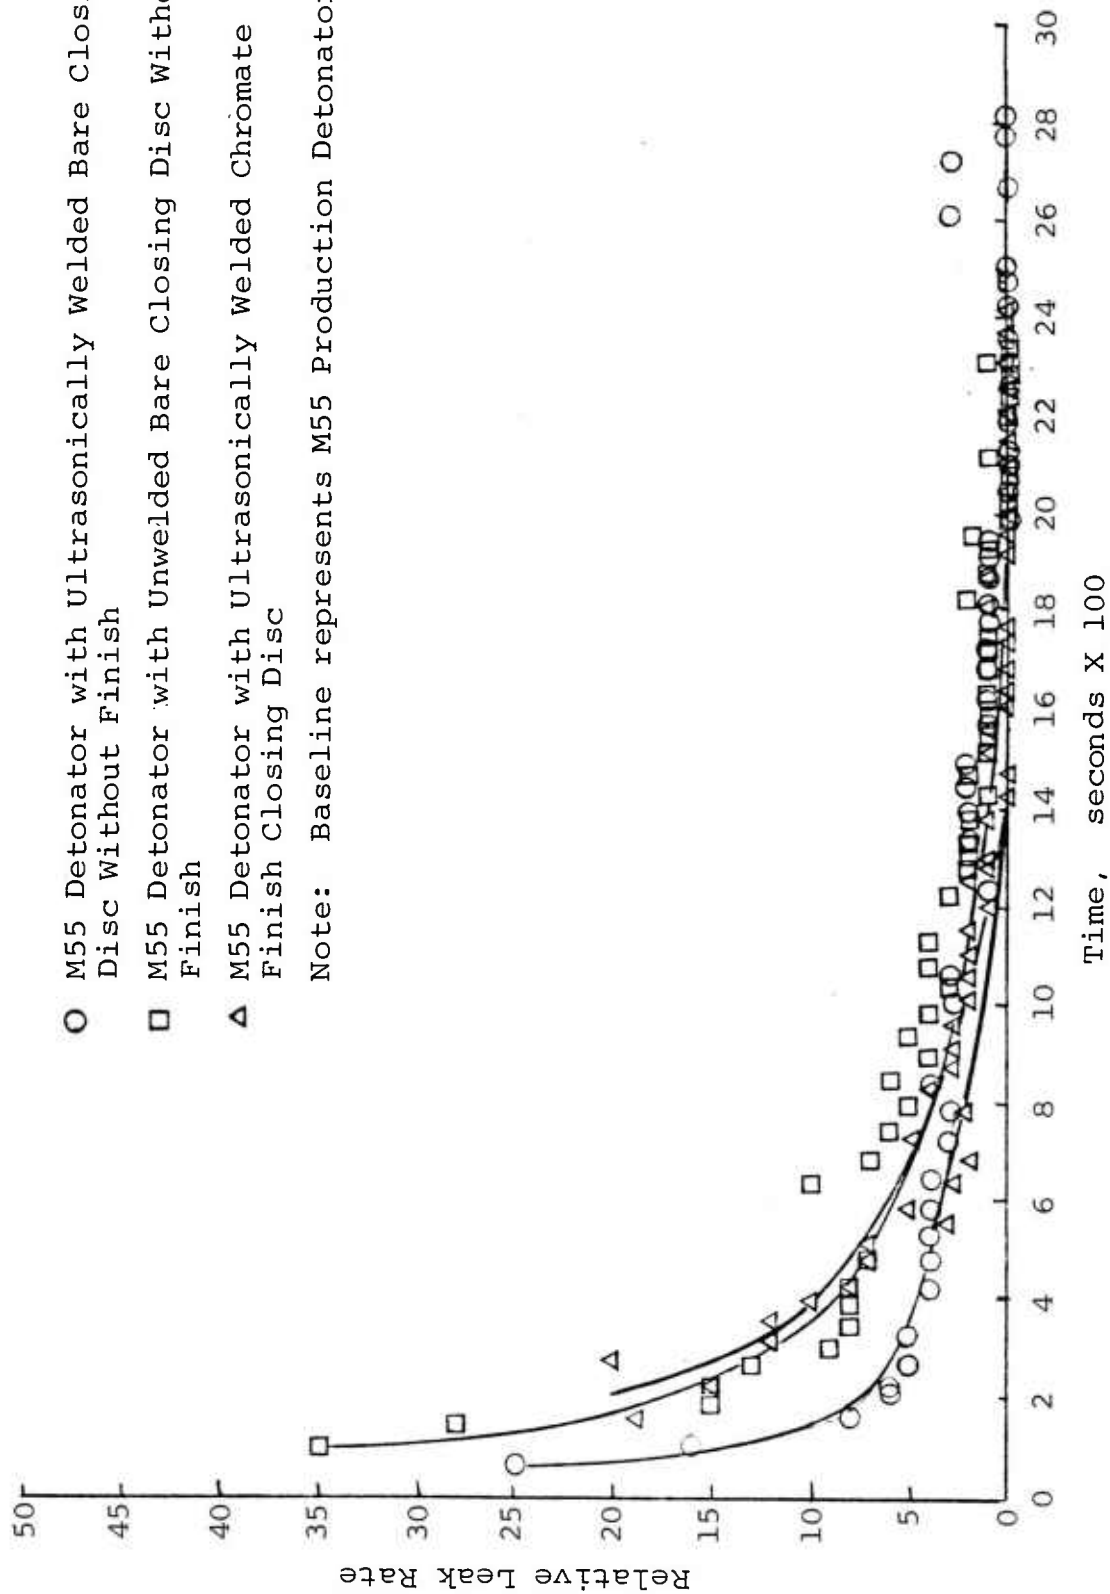
Figure C-2. Relative leak rates for detonators

The bare crimped and unlacquered detonators when cycled through the MSLD gave readings which lasted up to 1800 seconds after bombing. Thus, the detonator held on to the helium charges for a long time, even though no hermetic barrier was present. Thus the standard production detonator was sealed perfectly.

The two welded types of detonators leaked at rates equivalent to that of the plain crimped unlacquered detonators. This can be seen clearly in the graph of Figure C-2.
